National Transportation Safety Board

Crash During Nonprecision Instrument Approach

Execuflight Hawker 700A
Akron, Ohio
November 10, 2015

Bill Tuccio, PhD
Cockpit Voice Recorder

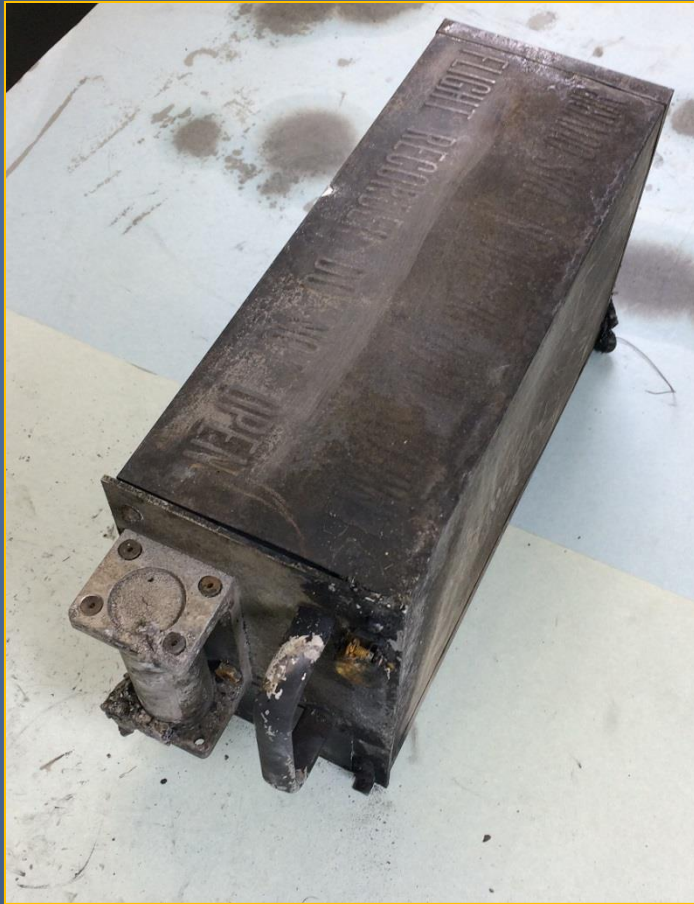
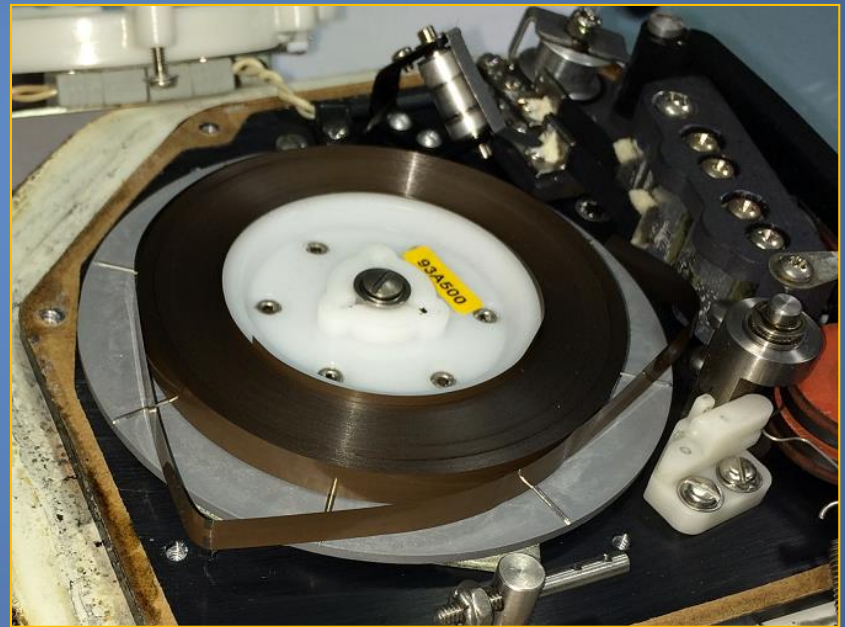
Sound Quality Issues
